Fuel Fill Cap Binds and Possible MIL Comes On With DTC P1456 (Supersedes 04-002, dated January 30, 2004)

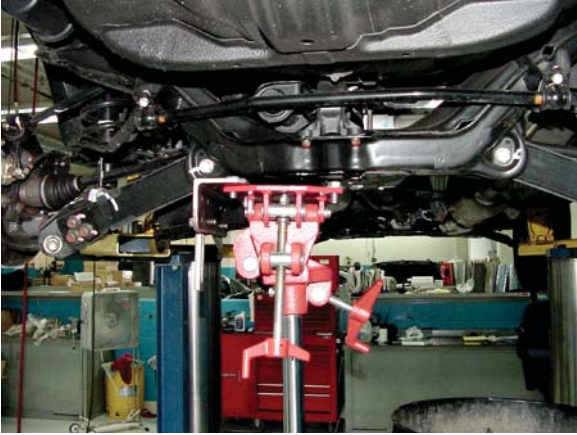
1. Raise the vehicle on a lift, and remove the left rear wheel.
2. Remove the three EVAP canister mounting bolts. Let the canister hang in place.
3. Support the rear suspension cross beam with a powertrain lift or commercially available jack as shown.

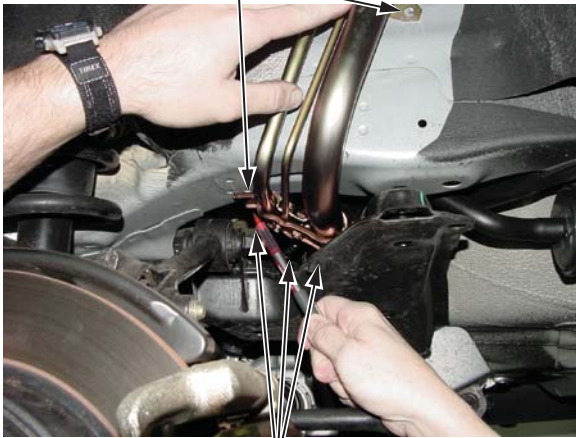
FUEL FILL PIPE
BRACKET BOLTS

4. Disconnect the fuel fill pipe hoses from the fuel fill pipe.

Disconnect the
fuel fill pipe hoses.

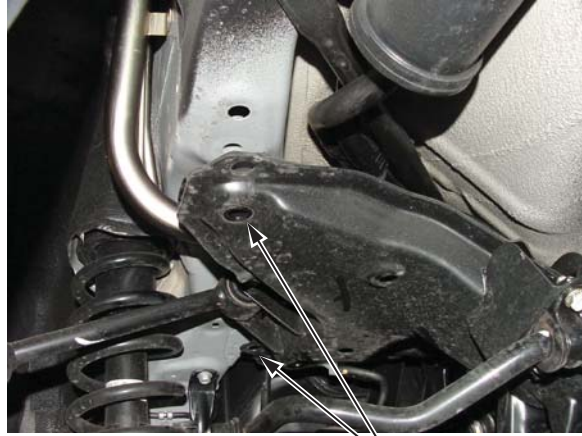
5. Remove the two lower rear cross beam bolts, the two fuel fill pipe bracket bolts, and the fuel fill pipe gasket.

Remove the cross
beam bolts.

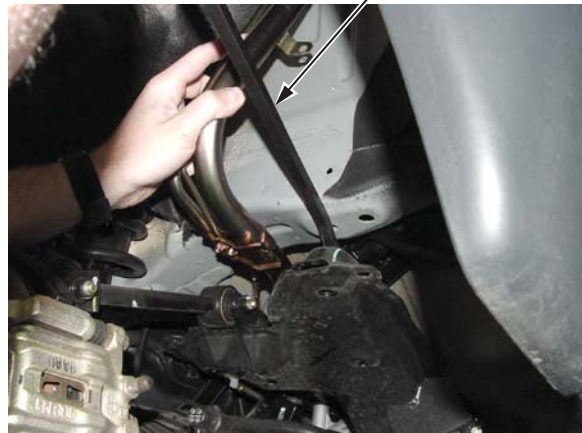
PRY BAR

6. Using a pry bar, move the rear cross beam down to make room to remove the fuel fill pipe.

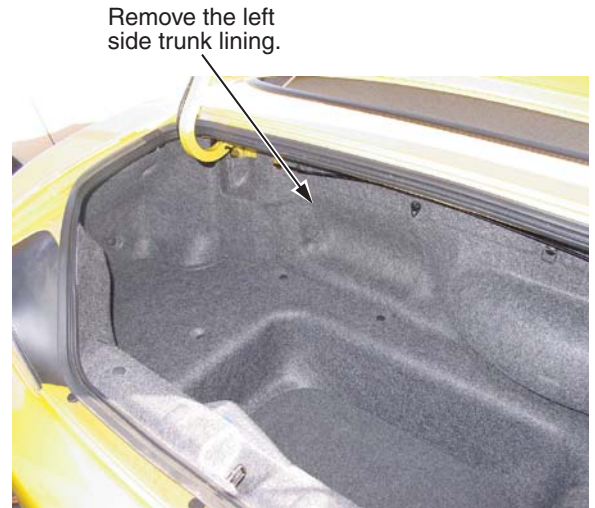
1. Remove the left side trunk lining.

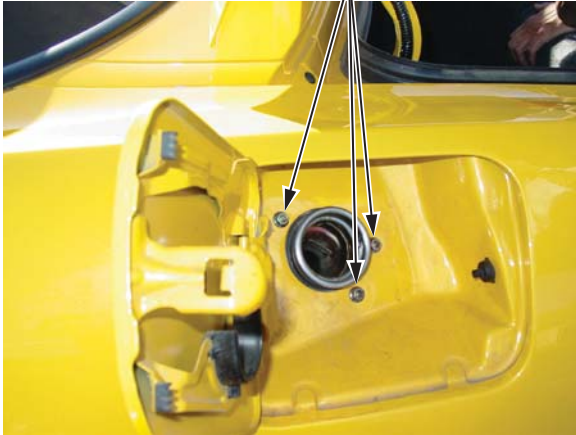
3. Remove the fuel fill pipe attachment nuts.

Remove these nuts.

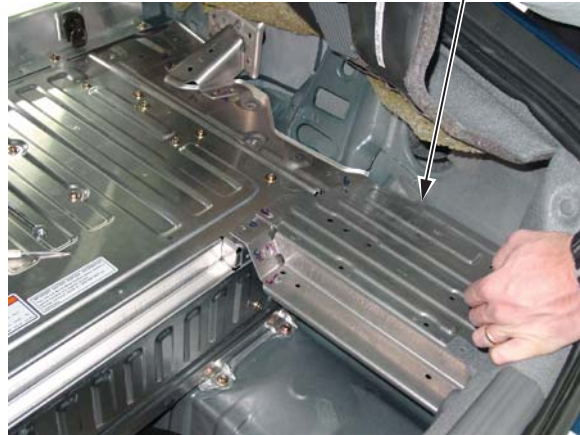
TRUNK SHELF SUPPORT

1. Remove the trunk lining and the cargo box. (See page 20-44 of the 2000–04 Insight Service Manual.)
2. Remove the right trunk side bulkhead and the right side trunk shelf support.

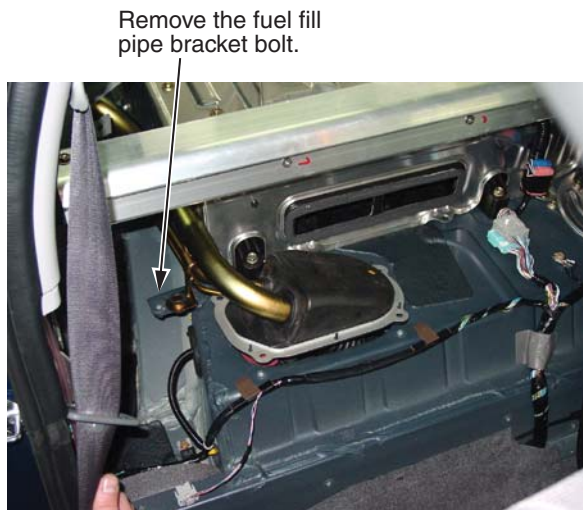
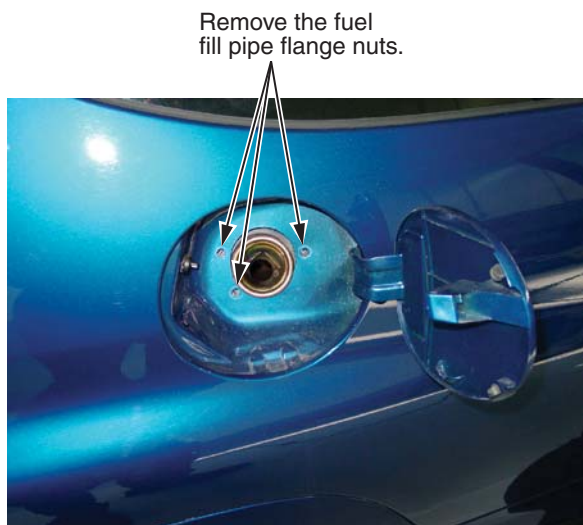
5. Slide the fuel fill pipe grommet upward. Then disconnect the fuel fill pipe hoses.
6. Remove the fuel fill pipe bracket bolt and the three fuel fill pipe flange nuts.
